Volume 2: Appendices

**Immediate Response Action Status  
Report No. 6 and Remedial  
Monitoring Report No. 9**

50 Tufts Street, Somerville, Massachusetts

November 10, 2008  
Project No. 04516-3

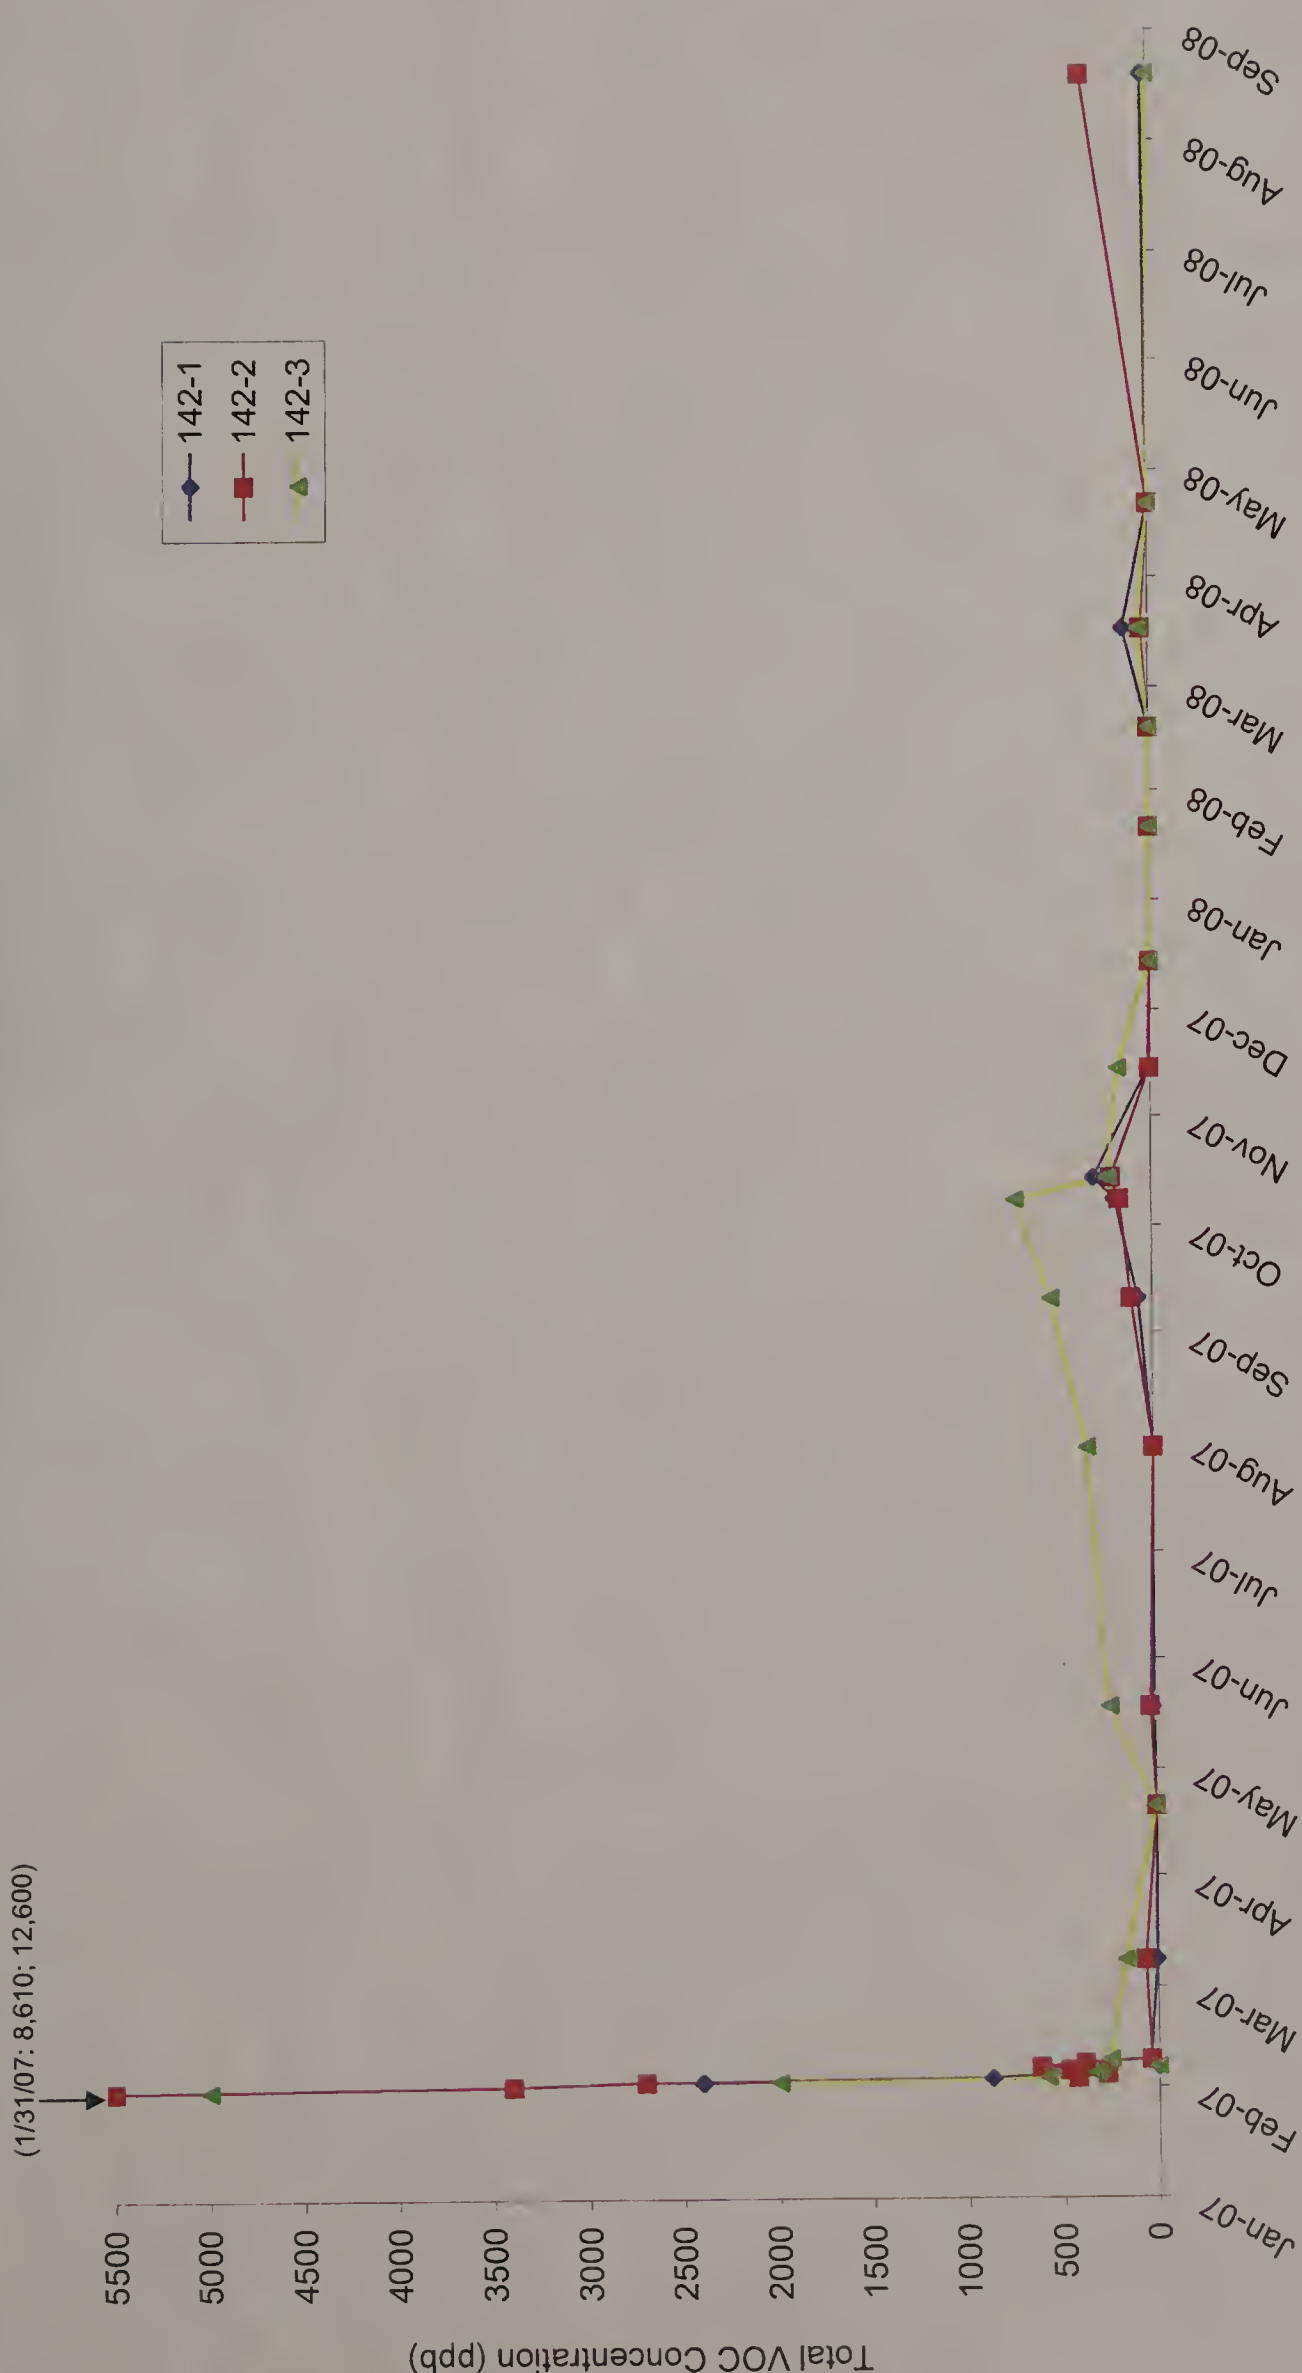
Graph 7

PID Monitoring Data: January 31, 2007 - September 30, 2008  
Total VOC Concentrations by PID at Exterior Monitoring Points - Room 142  
Capuano Center  
Somerville, Massachusetts

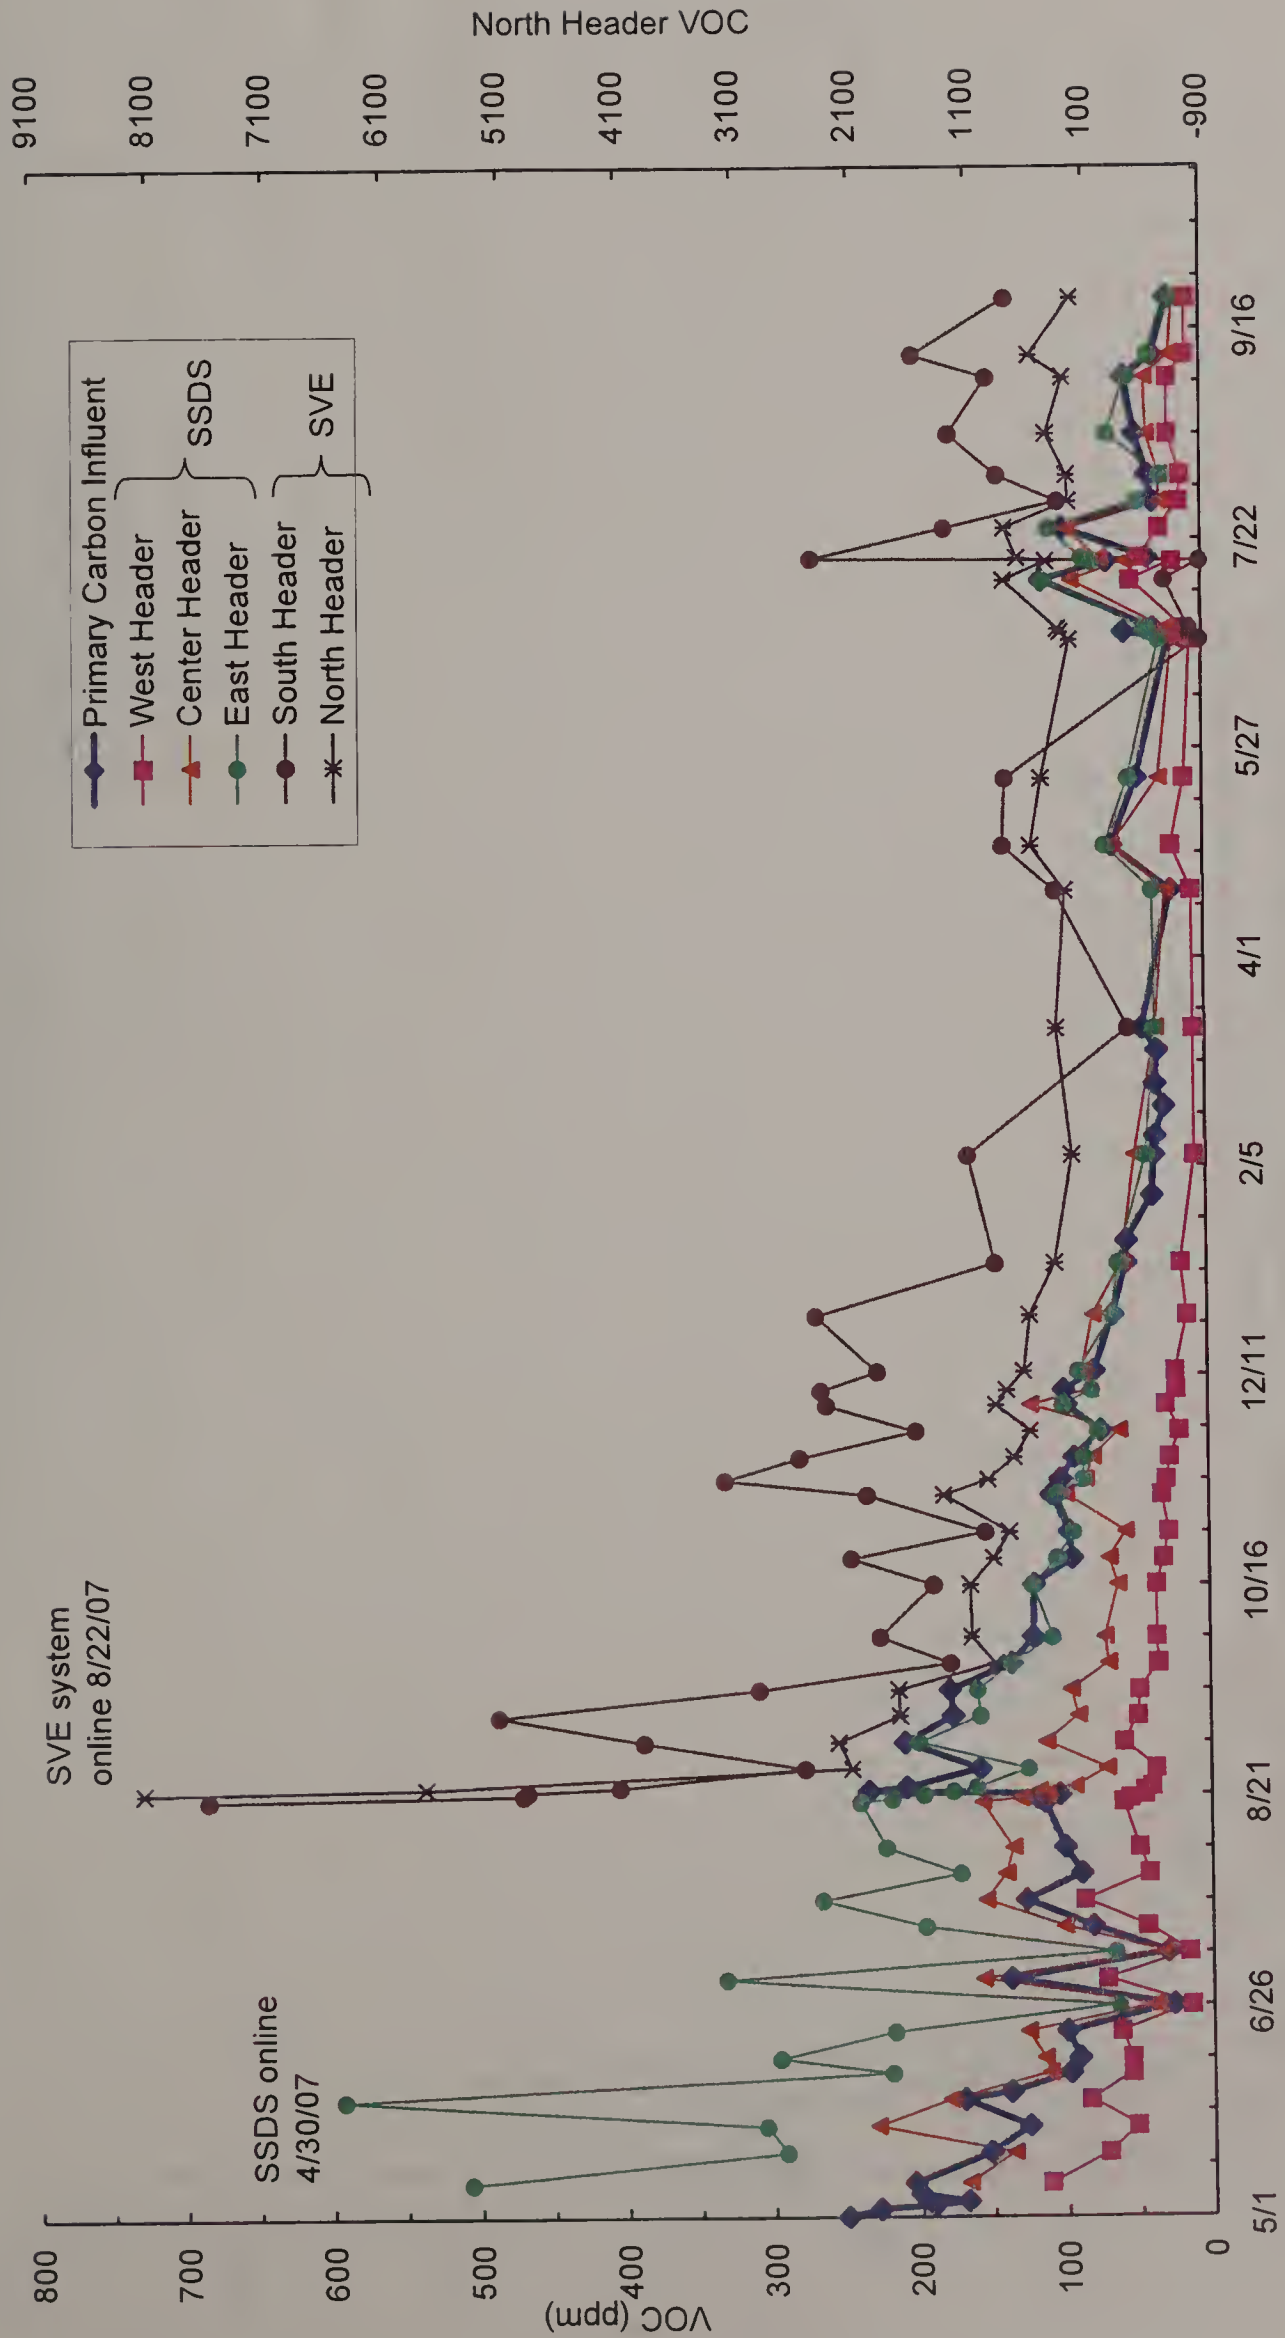
Graph 1  
SSDS and SVE Header Pipe VOC Concentrations 50 Tufts Street  
50 Tufts Street  
Somerville, Massachusetts

--VOC results on 6/26 and 7/10 using a PID may be biased low due to a low flow rate through the PID.

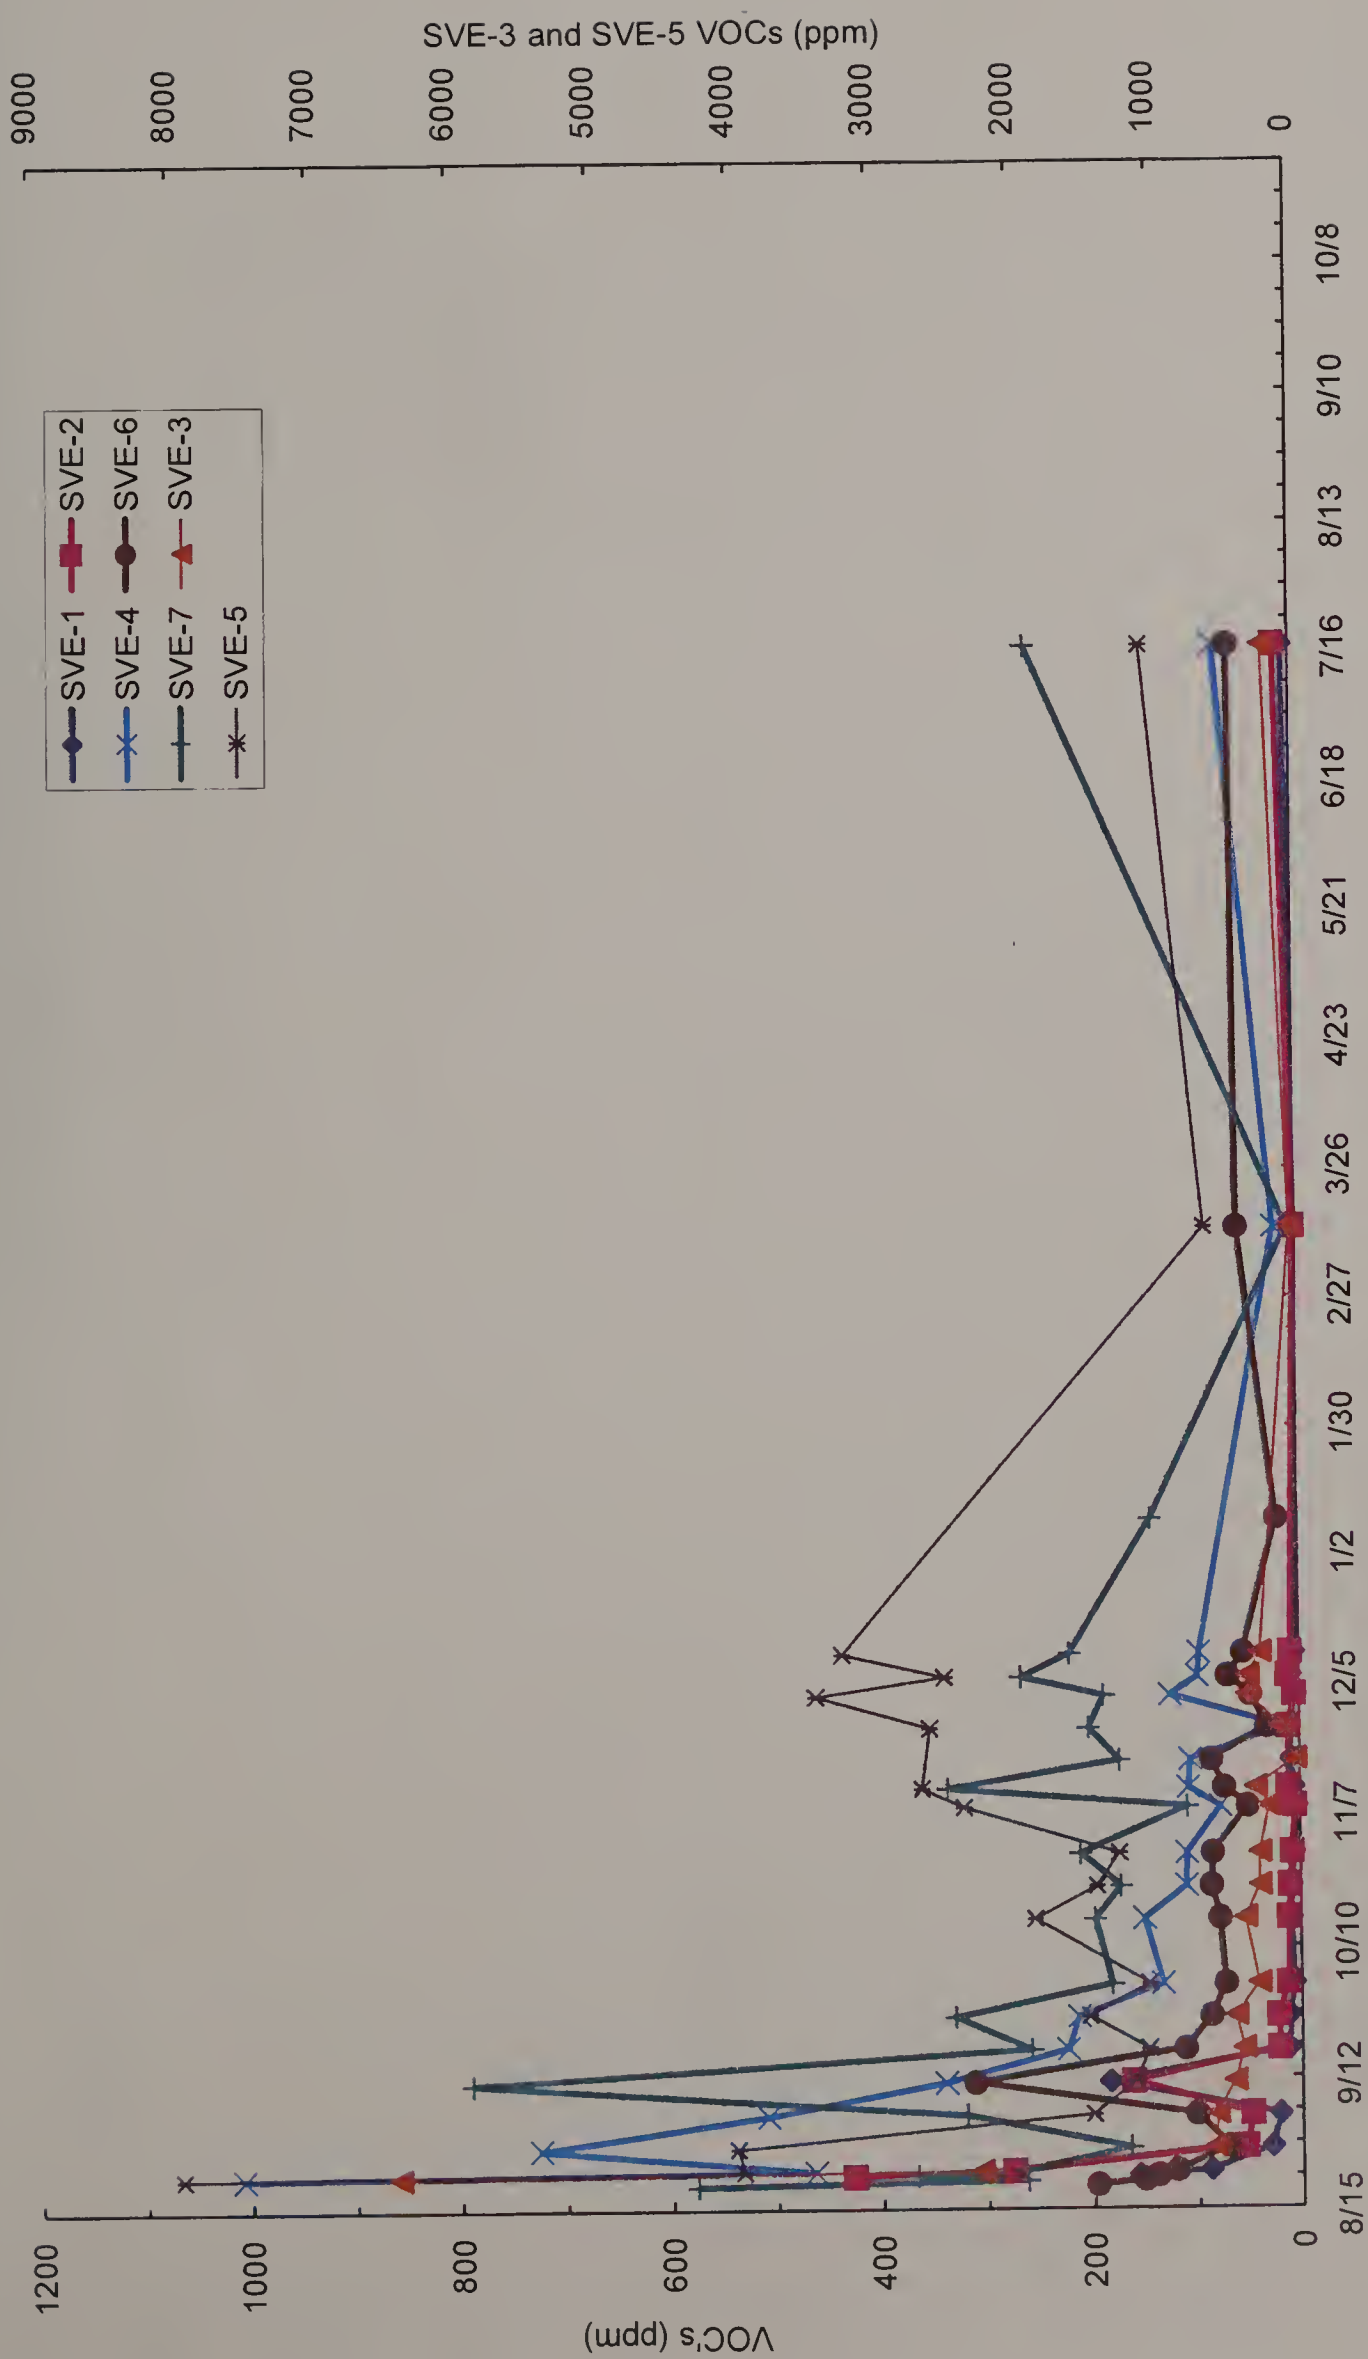
**Graph 2**  
**SVE Extraction Point VOC Concentrations**  
 50 Tufts Street  
 Somerville, Massachusetts

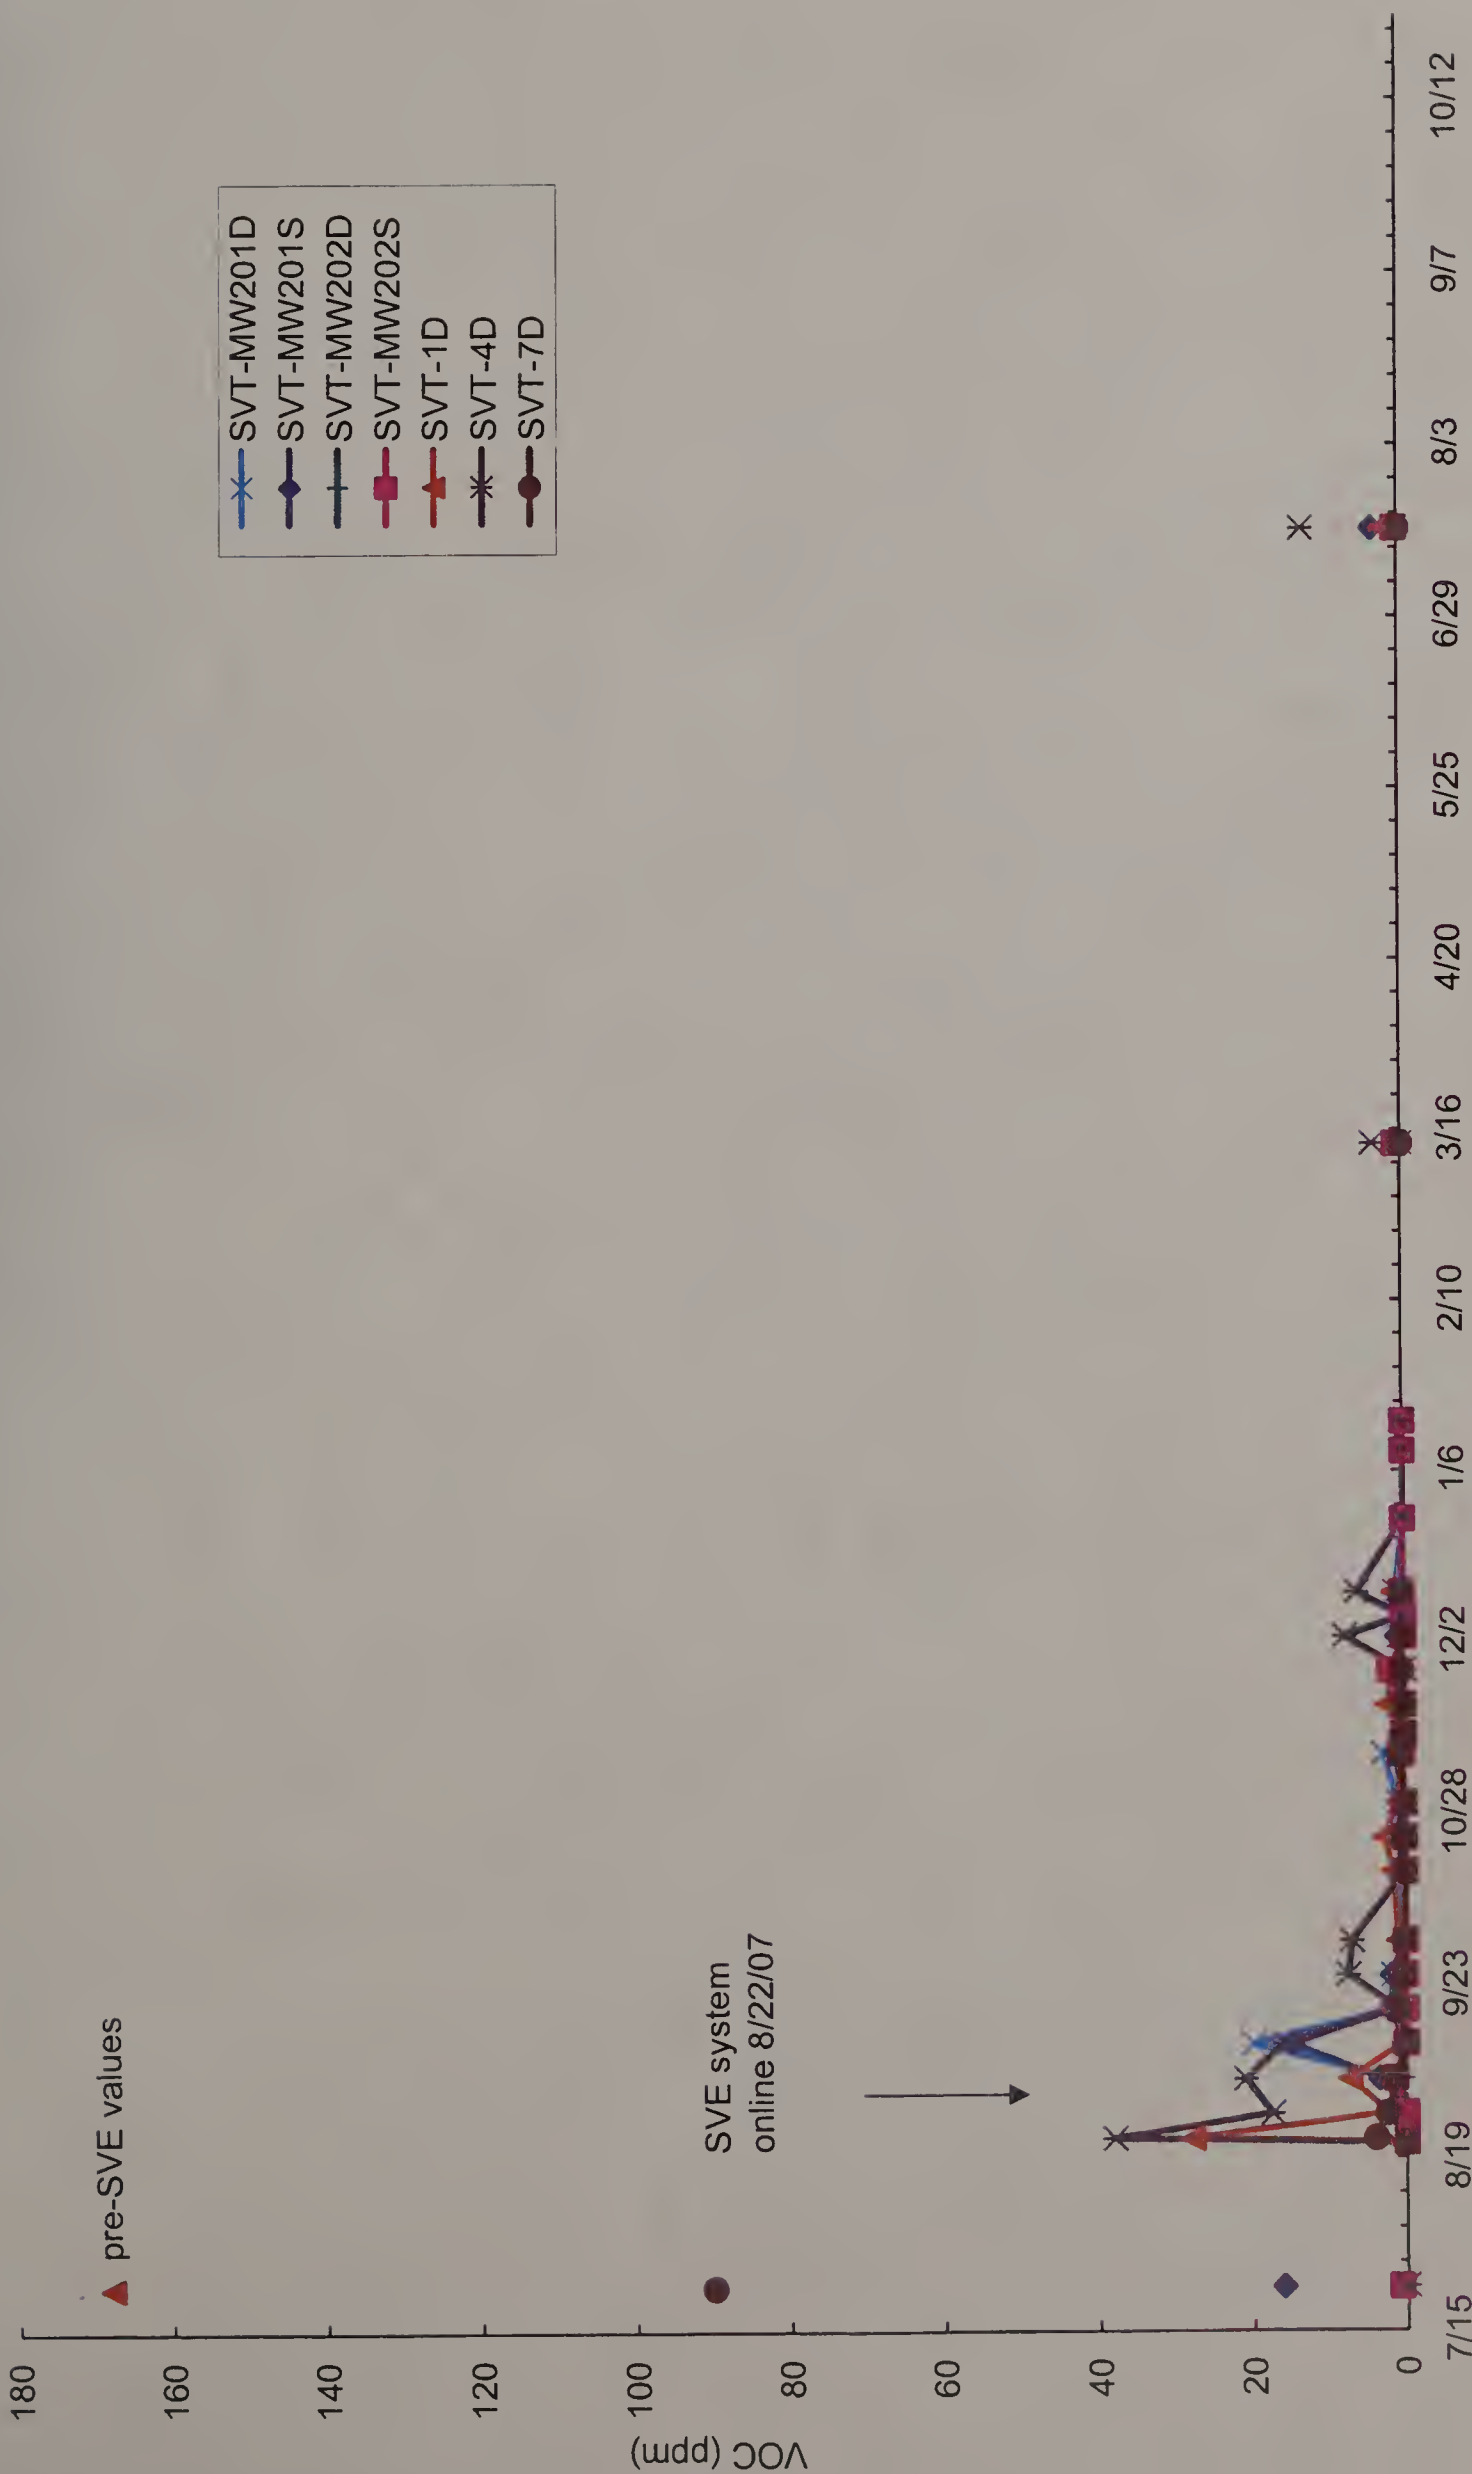
Graph 3

Soil Vapor Monitoring Point VOC Concentrations 60 Tufts Street  
50 Tufts Street  
Somerville, Massachusetts
